Cascade Bridge Study

Burlington, Iowa

January 7, 2020

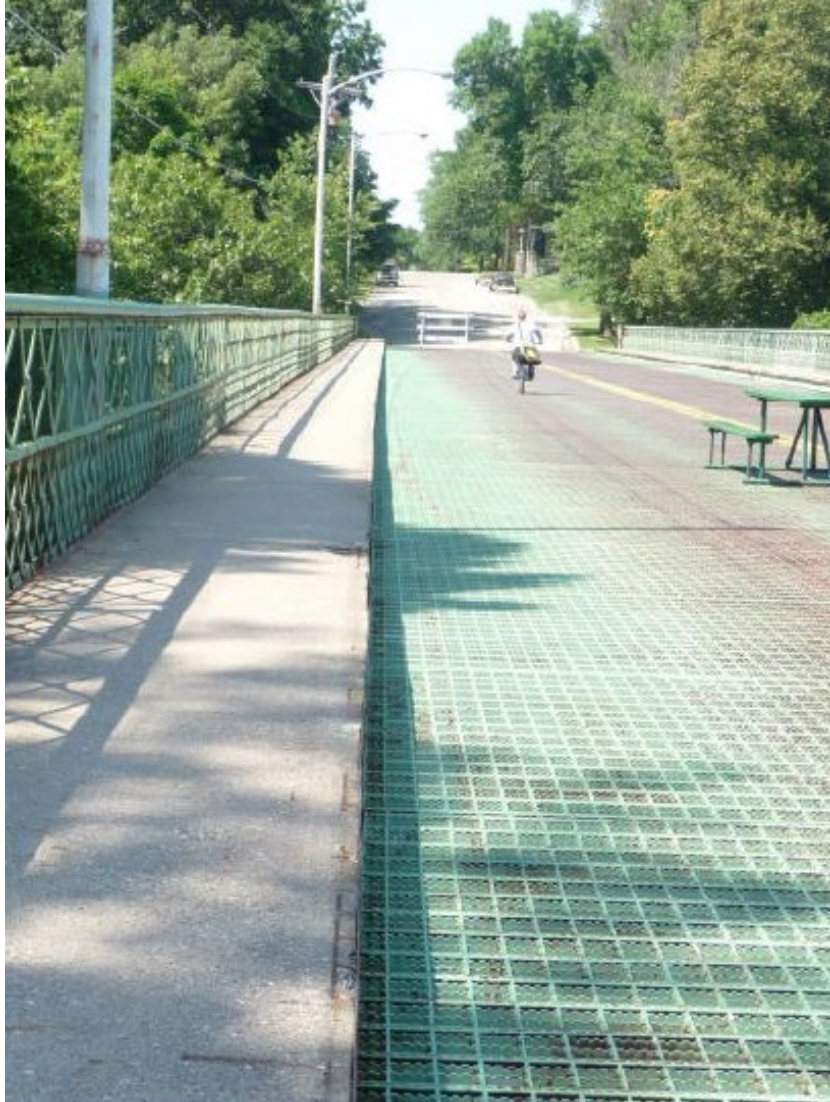
Previous Repairs

- 1953
 - New truss bearing shoes
 - New horizontal bracing
 - Reinforcing of steel piers
 - Reinforcing of some diagonal eyebars

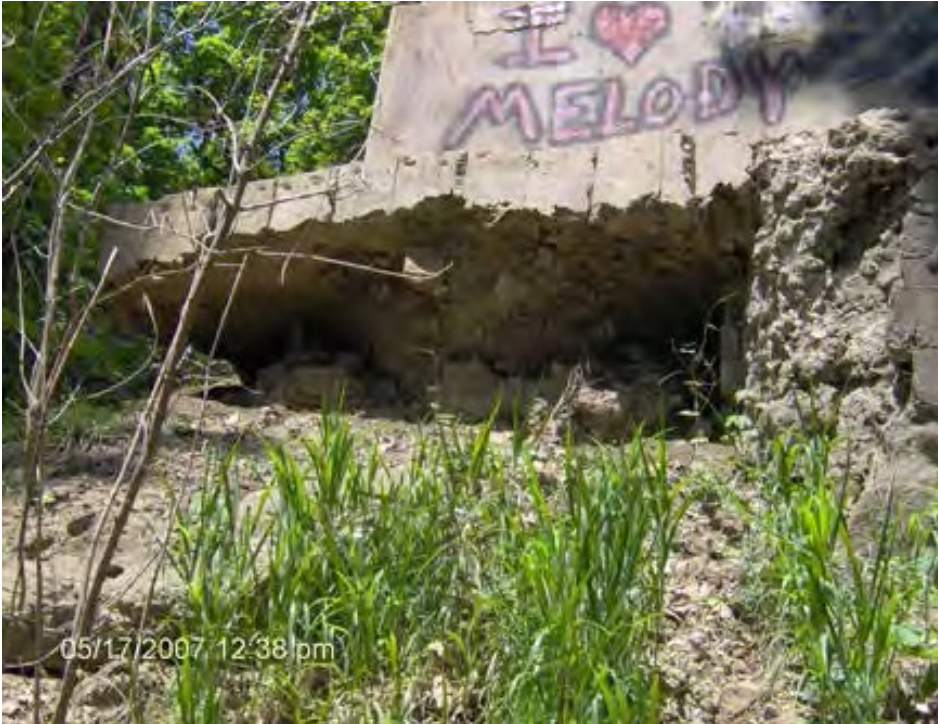
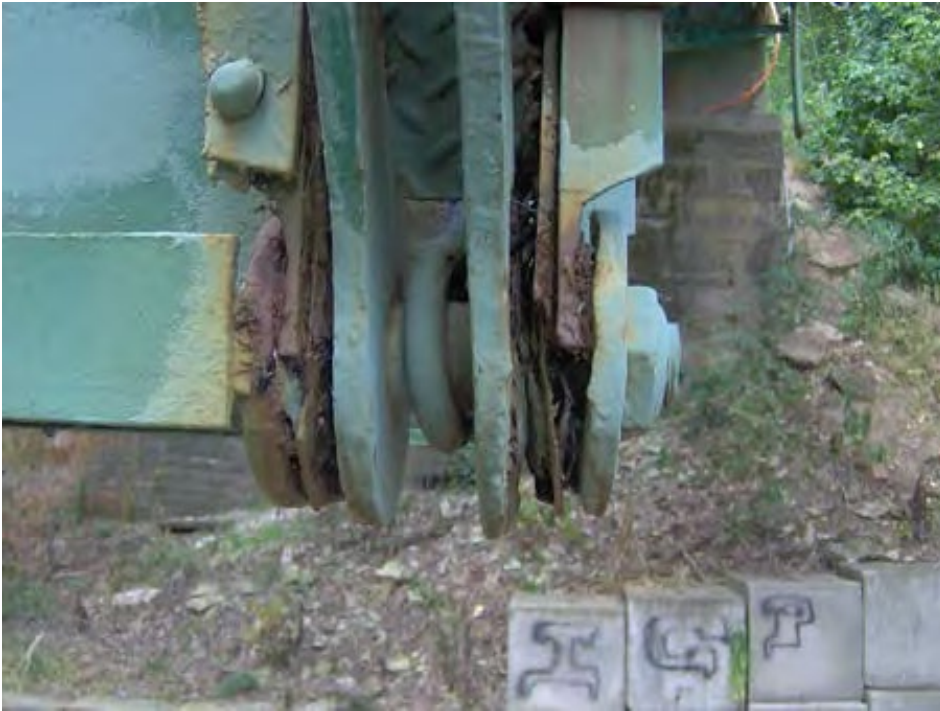
Previous Repairs

- 1998
 - Removal of existing concrete foundation at Pier 3, replaced with new concrete grade beam and caissons cored into limestone bedrock
 - Concrete abutment repairs
